**PRESERVATION AND URBAN RELIGIOUS INSTITUTIONS:
OPPORTUNITIES AND STRATEGIES FOR THE PRESERVATION OF THE
NINETEENTH STREET BAPTIST CHURCH**

Molly Anne Sheehan

A THESIS

Nineteenth Street Baptist Church Condition Survey

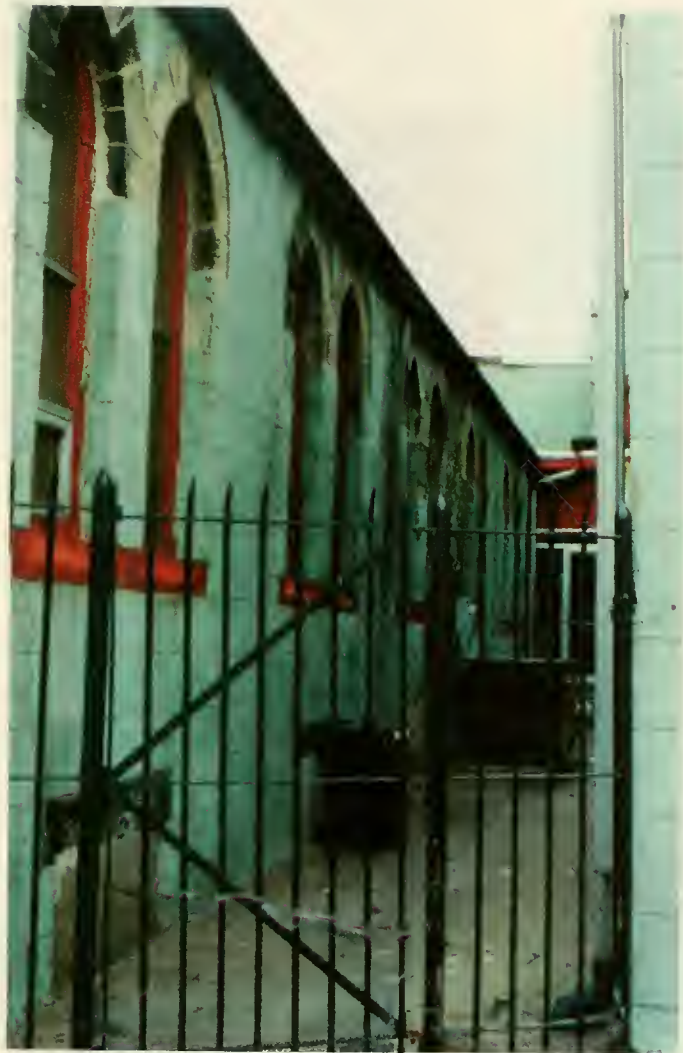
South Elevation of Church Building (S)

Windows
Number: 13 (basement openings have been filled)
Condition: Good
Notes: These window types and conditions are consistent with those noted on other elevations of the church building (stained glass with protective exterior storms). (refer to photograph T)
Masonry
Type: Stucco
Condition: Poor
Notes: The stucco on this elevation exhibits the same conditions noted elsewhere on the church building (cracks, disaggregation, loss of bond to substrate, water damage, staining and bio-growth). The stucco application does not appear to be as smooth as that which was observed on the west and north elevations of the church building. (refer to photographs S, T and U)
Type: Serpentine
Condition: Poor
Notes: Condition of serpentine on this elevation is consistent with that noted for the other elevations of the church building. (refer to photograph U)
Type: Limestone (brown/tan)
Condition: Good
Notes: There appears to be a tan limestone horizontal band two feet from the foundation not noticed elsewhere on the church building. The same staining and painted conditions observed on this elevation is similar to that noted on the other elevations of the church building. The mortar between the limestone units seems to be in better condition on this elevation as oppose to the other three elevations of the church building. (refer to photograph S)
